CEBAC Community archaeology walks No 7

This week we followed Allt Cearagol up to the confluence with Allt Loch an Eallaich, then up to Cnoc a Mhaide, Cnocan a' Phrige and back to the start via Cnoc an Soluis. Local tradition has it that this river system had many illicit stills.

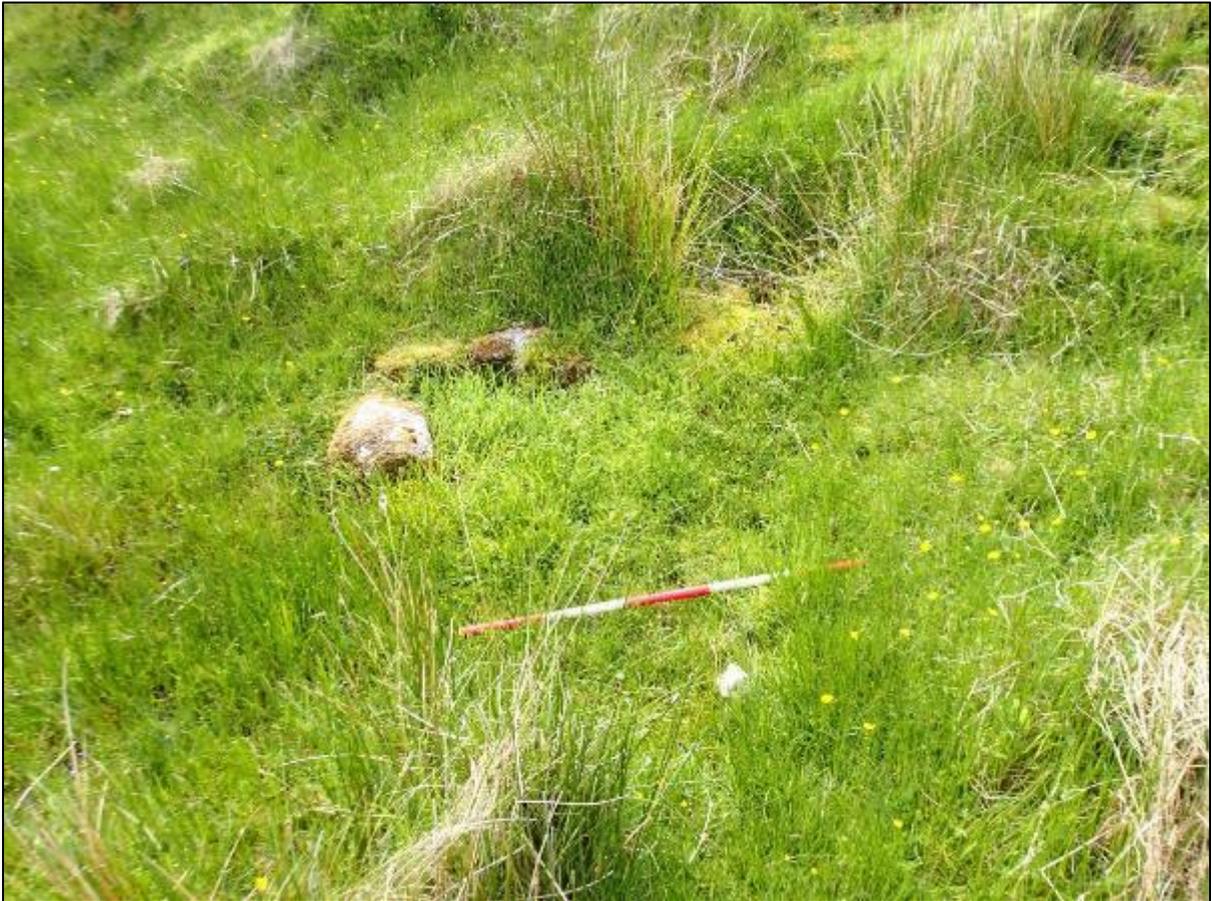
At the right hand arrow in Fig 4, we couldn't make out the channels as shown on the map but there was a well or spring on the south bank, now over grown:

Figure 5: Well, now overgrown

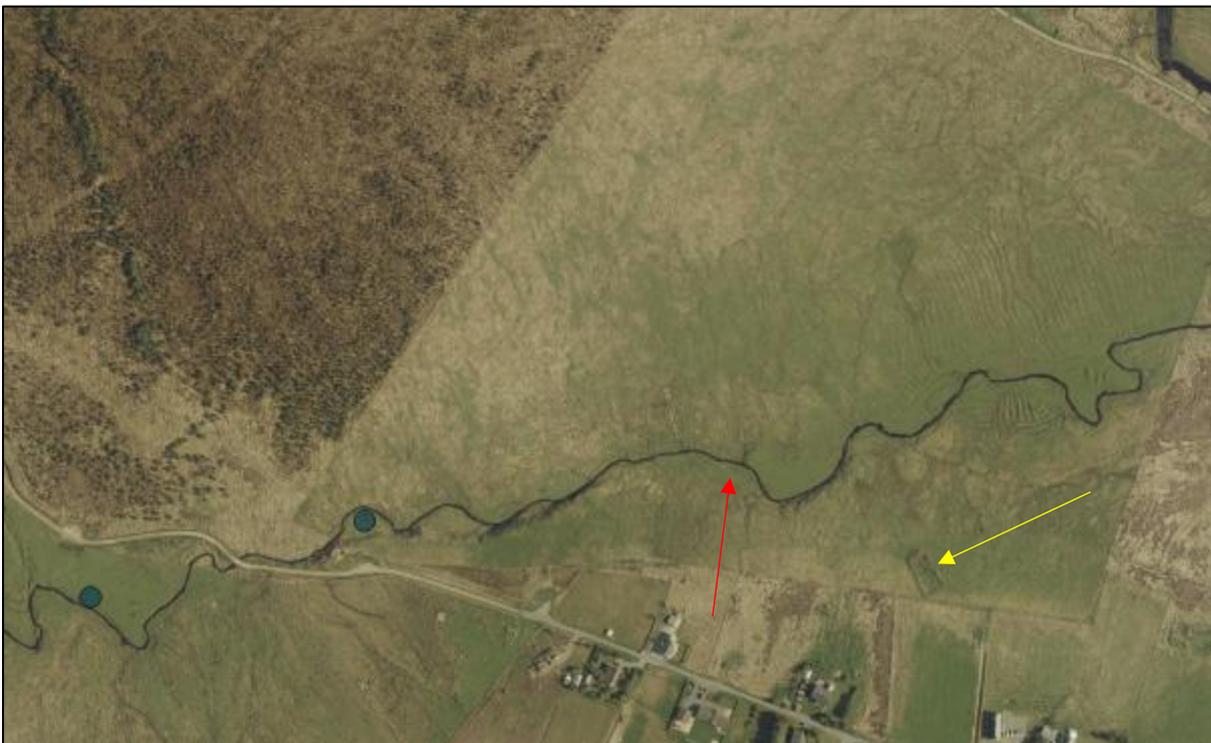
Figure 6: Red arrow where the 1st edition boundary was supposed to cross, near the Well and the strange water channels, at NB 47655 41612. No sign of the boundary and little sign of the channels could be made out. The yellow arrow points to what was a stone fank (marked on modern maps)

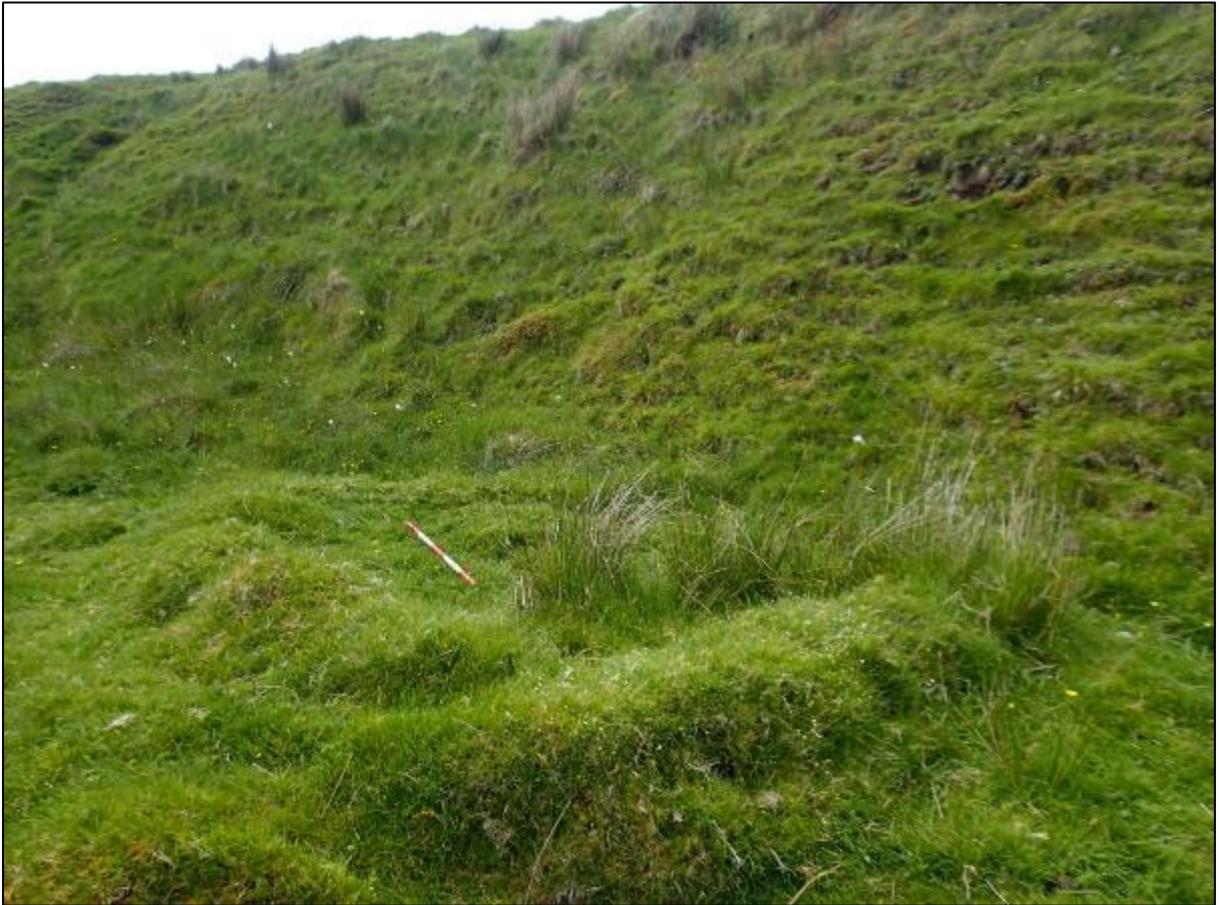
The footings of this building were found. All that remains are c.0.3m high turf wall footings of a c3m x 2m rectangular building, built hard up against a steep bank. CANMORE suggests that it might be a shieling hut but the observed footprint is unlike any shieling we have seen so far. It does however conform to the shape of the mainland illicit stills which we found out about in Walk No 3. We also noticed that it was impossible to see from upstream and likewise well-hidden on the approach, or from any other angle. We therefore suggest that it is rather the remains of an illicit still.

Figure 8: Site 2 – illicit still?

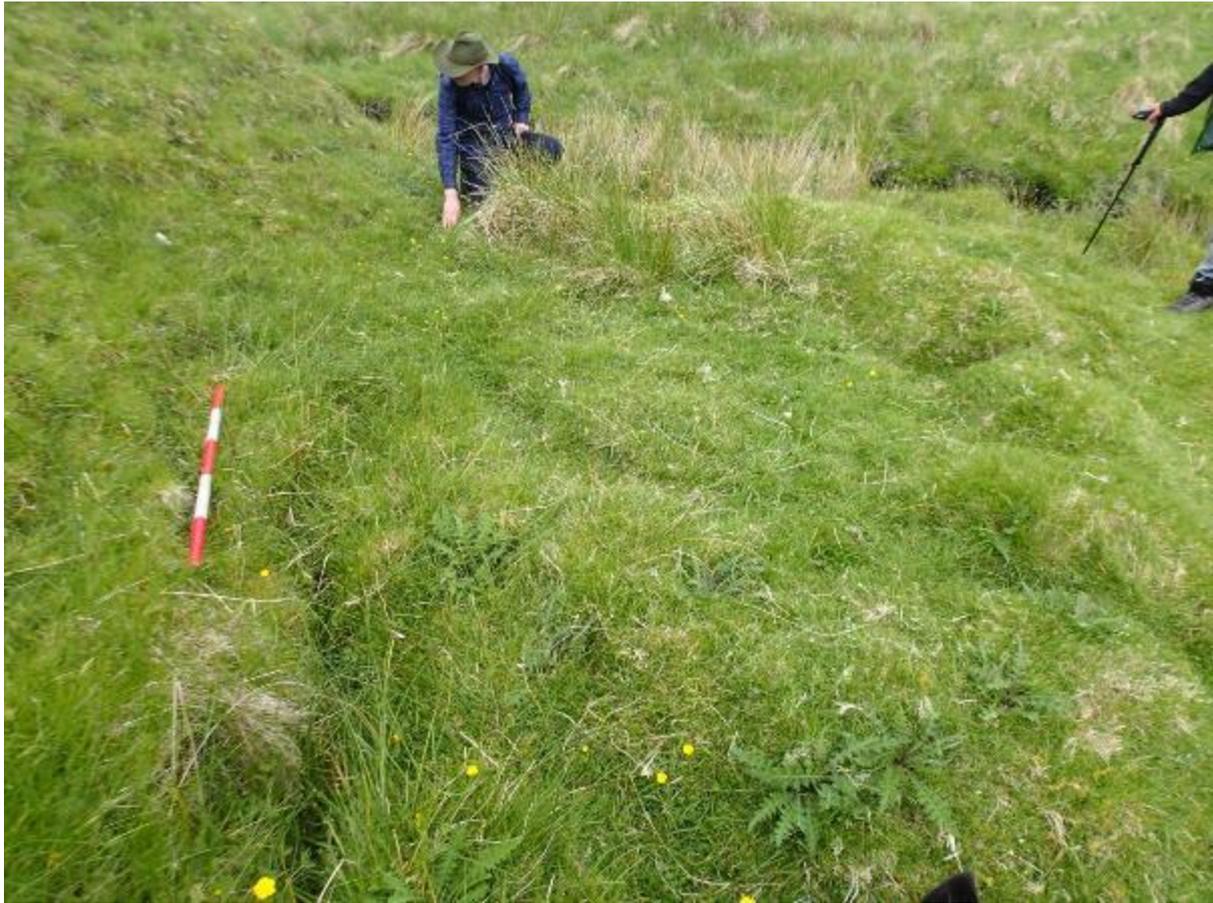
Figure 9: Site 2 again showing possible run out channel

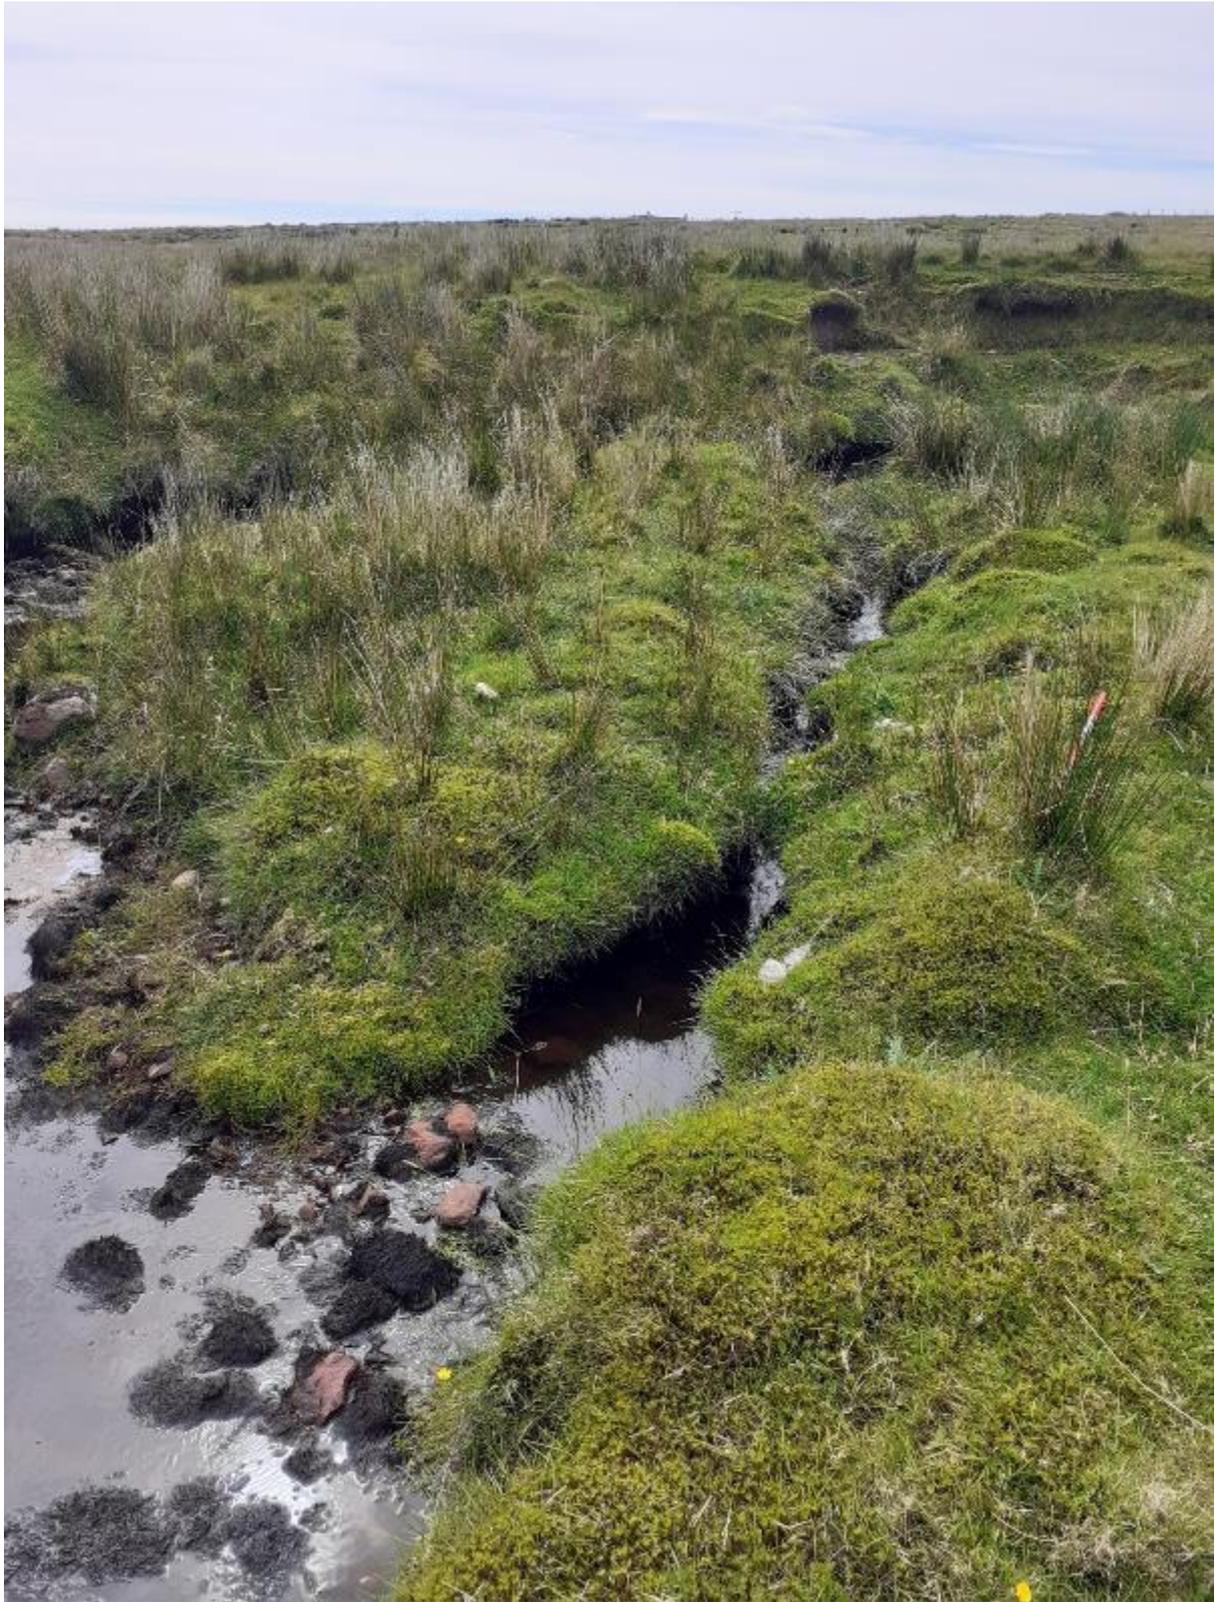
Figure 11: Site 4.

It is thought that site 4 might represent a fish trap – stony dams are made in the river and the narrow channel provides an easier way up for the Salmon. A wicker basket is wedged in the channel and catches the fish.

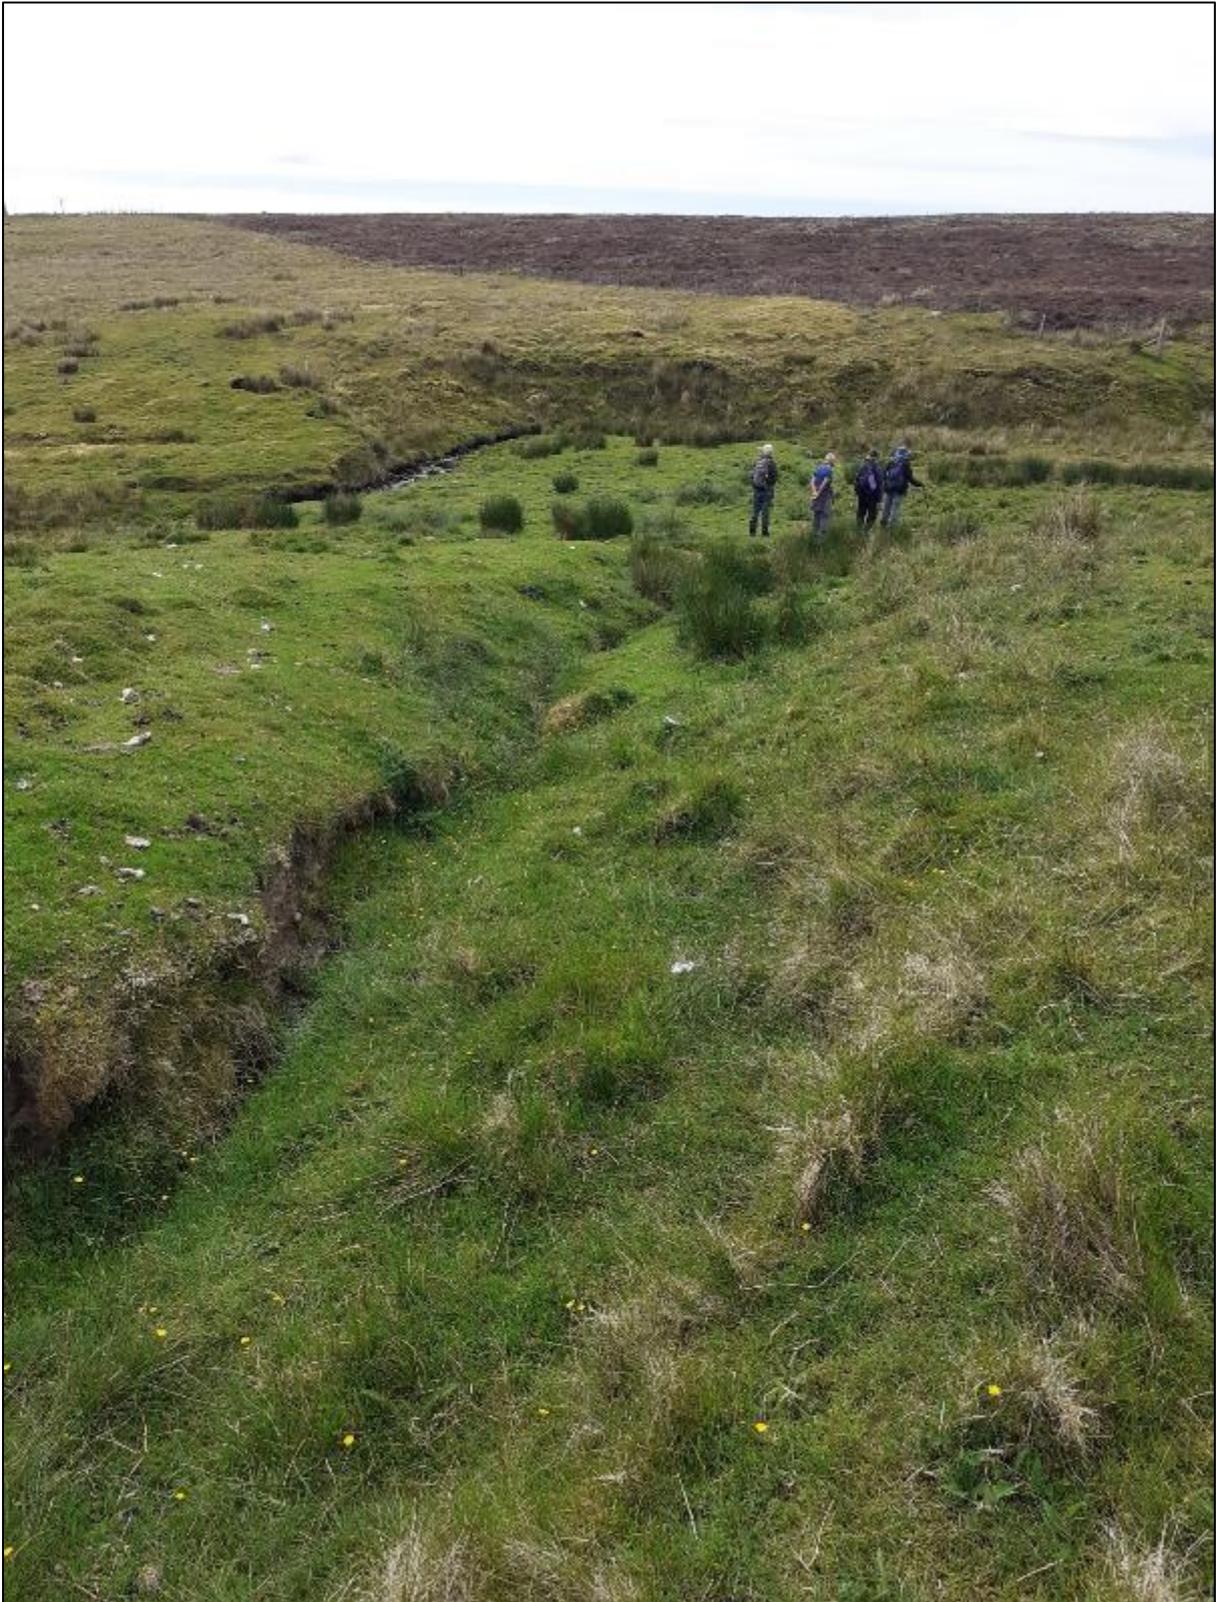
Figure 12: Site 5.

Site 5 is not natural, but is not shown on the early OS maps. This means it could have been either a lot earlier than 1852 and forgotten about by then, or after the 2nd edition in 1892. There is a possibility that it may have just been a substantial land drain, but it appears to continue on the other side of the stream, suggesting that it was some form of boundary

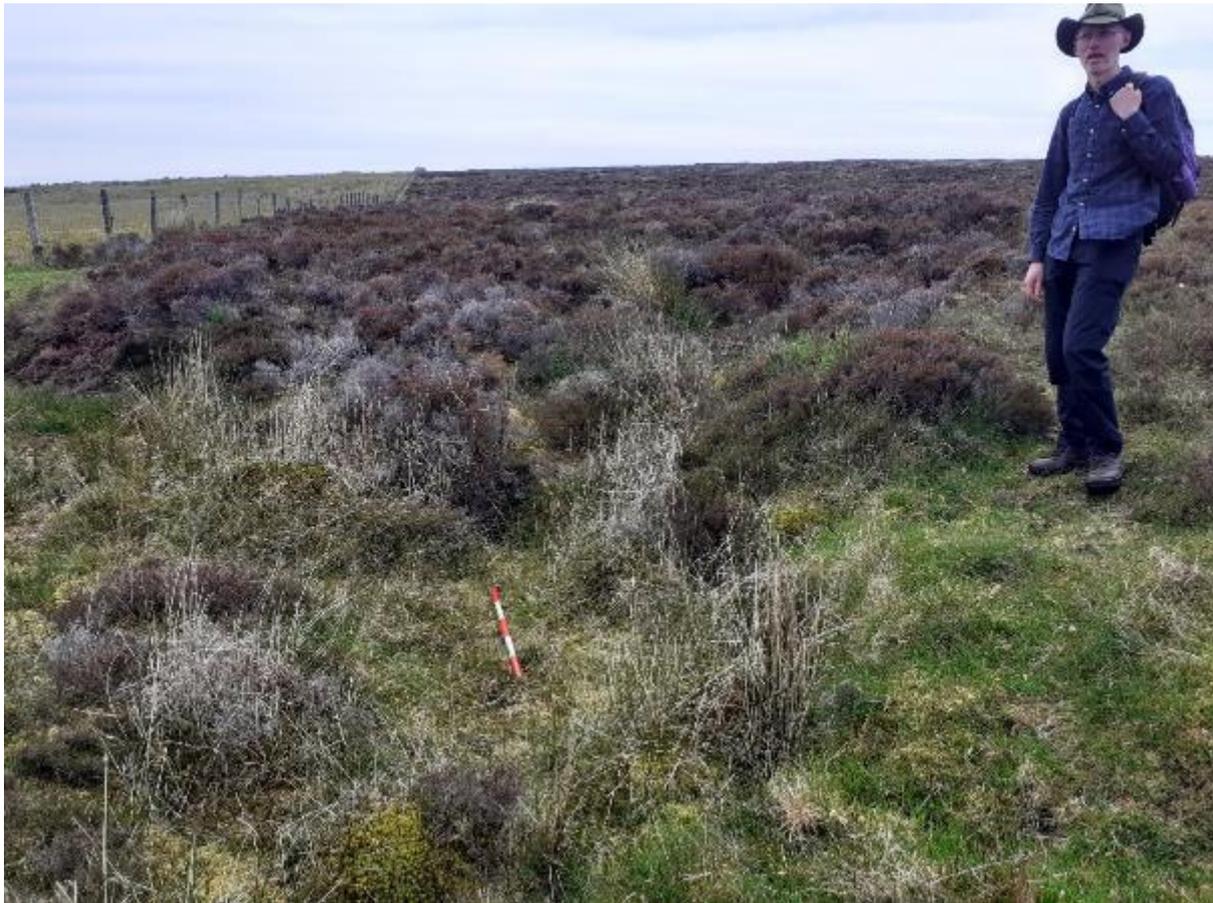
Figure 13: Site 5 again - possible boundary continuing into rough heather on the south bank

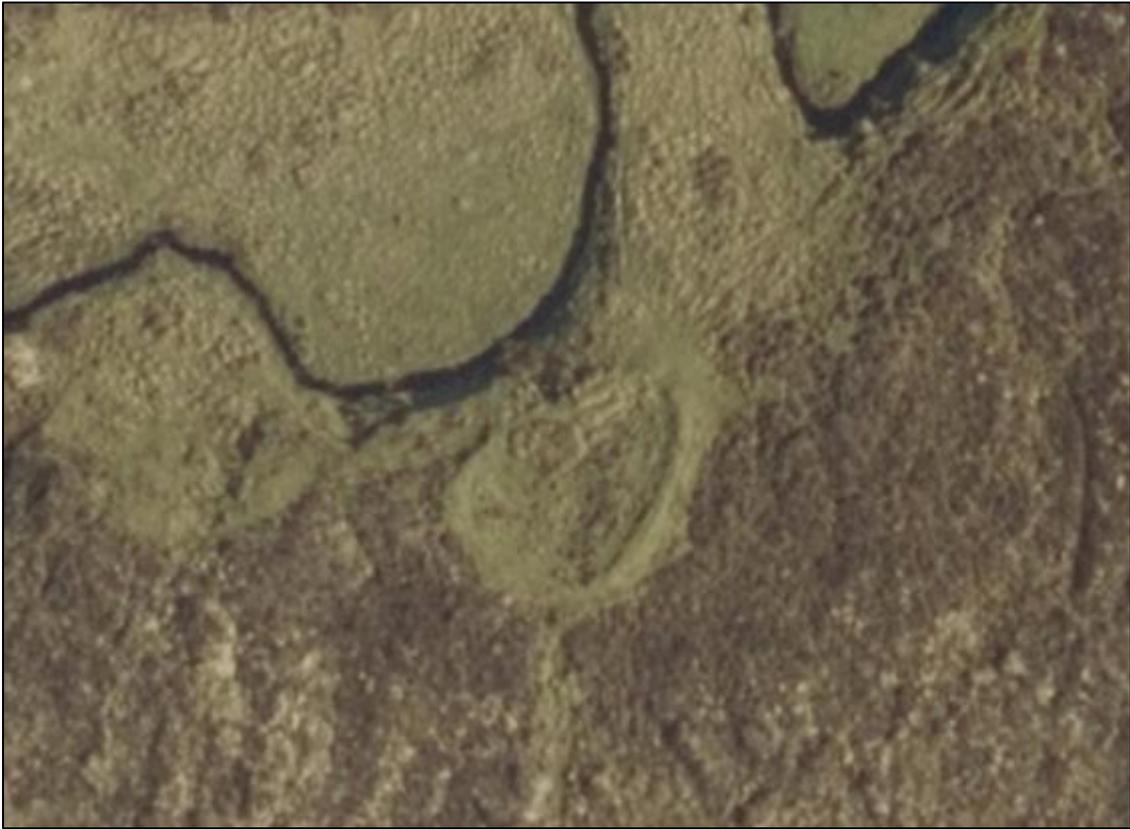
Moving upstream we came to **Site 6**: an “egg” shaped enclosure. This is not recorded on CANMORE but it is marked upon the modern map. It was c 20 x 10m, egg shaped in plan with the smaller end and the entrance to the downstream side. The walls were around 2m thick with large orthostatic stones lining the inside face visible in places. The whole thing was constructed on a gentle slope on the bank to the south side of the river, above the flood plain. The size, shape, solid construction and location near the shieling would suggest that this was a pen for cattle, but alternatively it may be an early “Fank” for Sheep.

Figure 14: Site 6. Substantial enclosure.

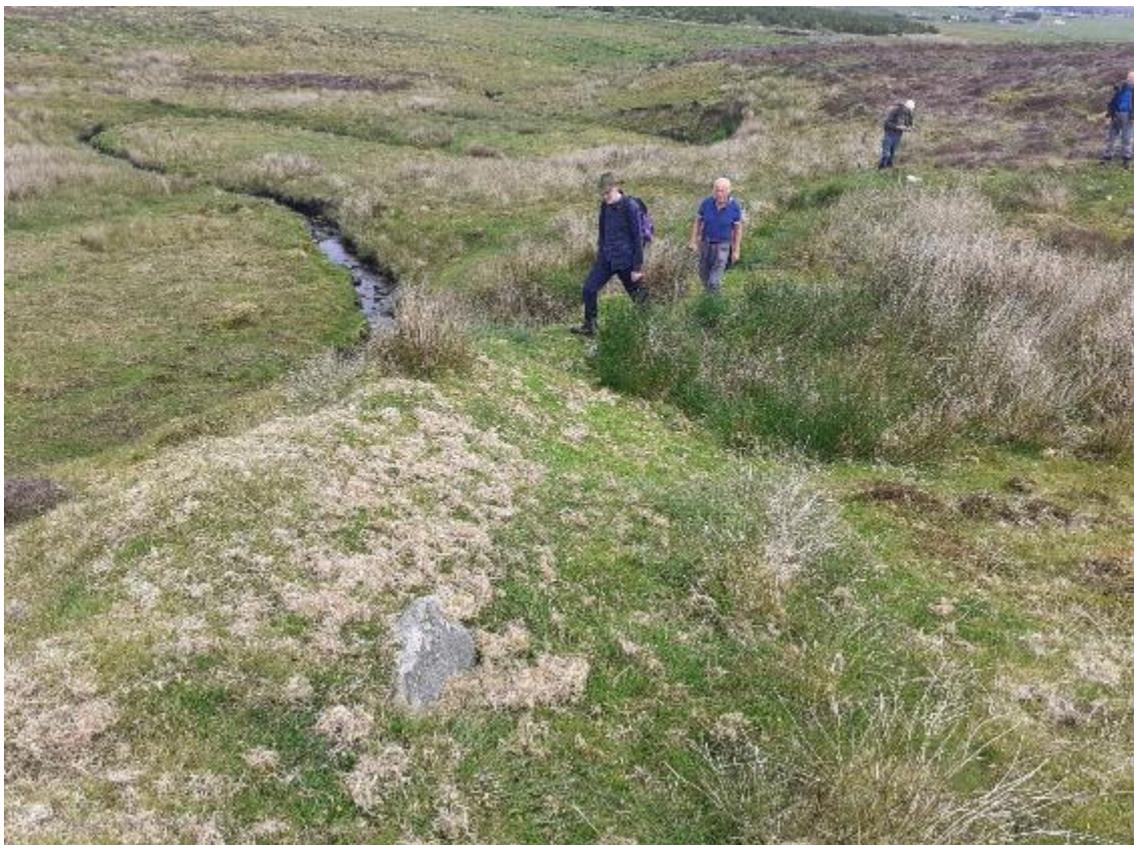
Figure 15: Looking downstream along the wall of the enclosure site 6. Note the large orthostatic stone wall facing on inside of the substantial wall, still visible in a few places around it's circuit..

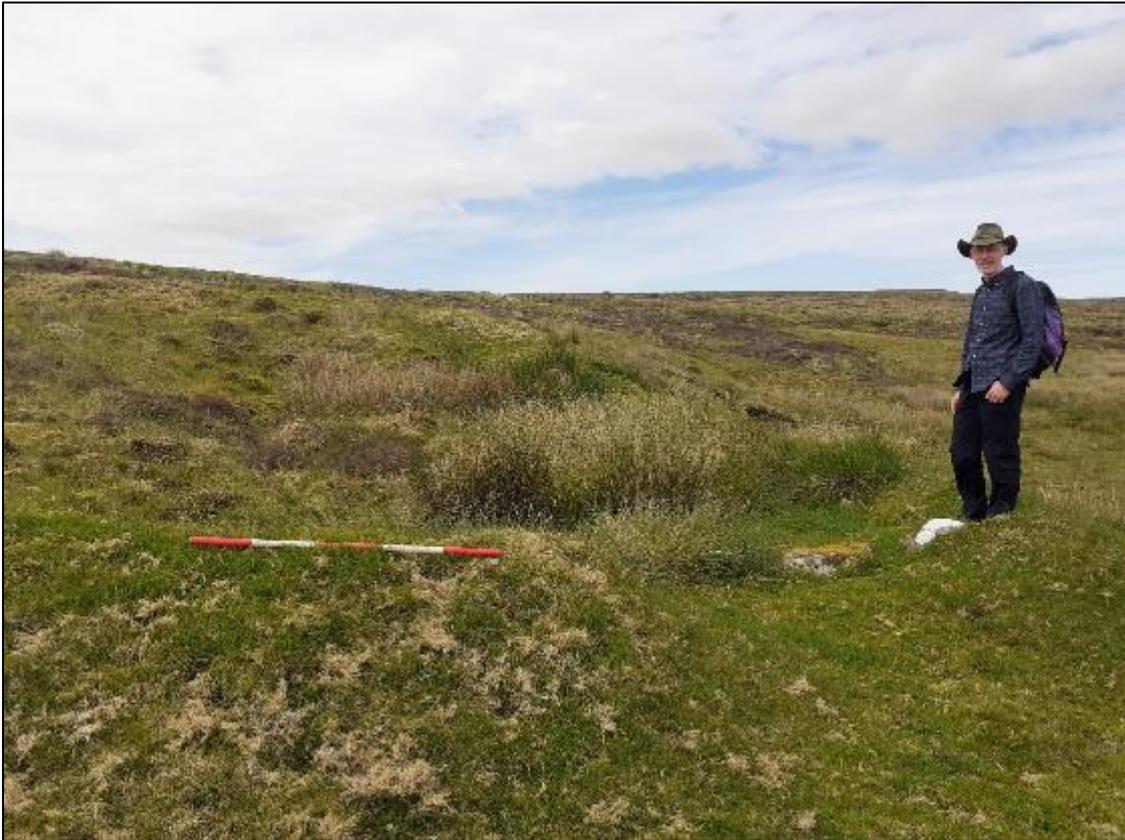
Figure 16: Site 6. What looked to be the entrance (between the scale and DI. Scale is 1.25m long)

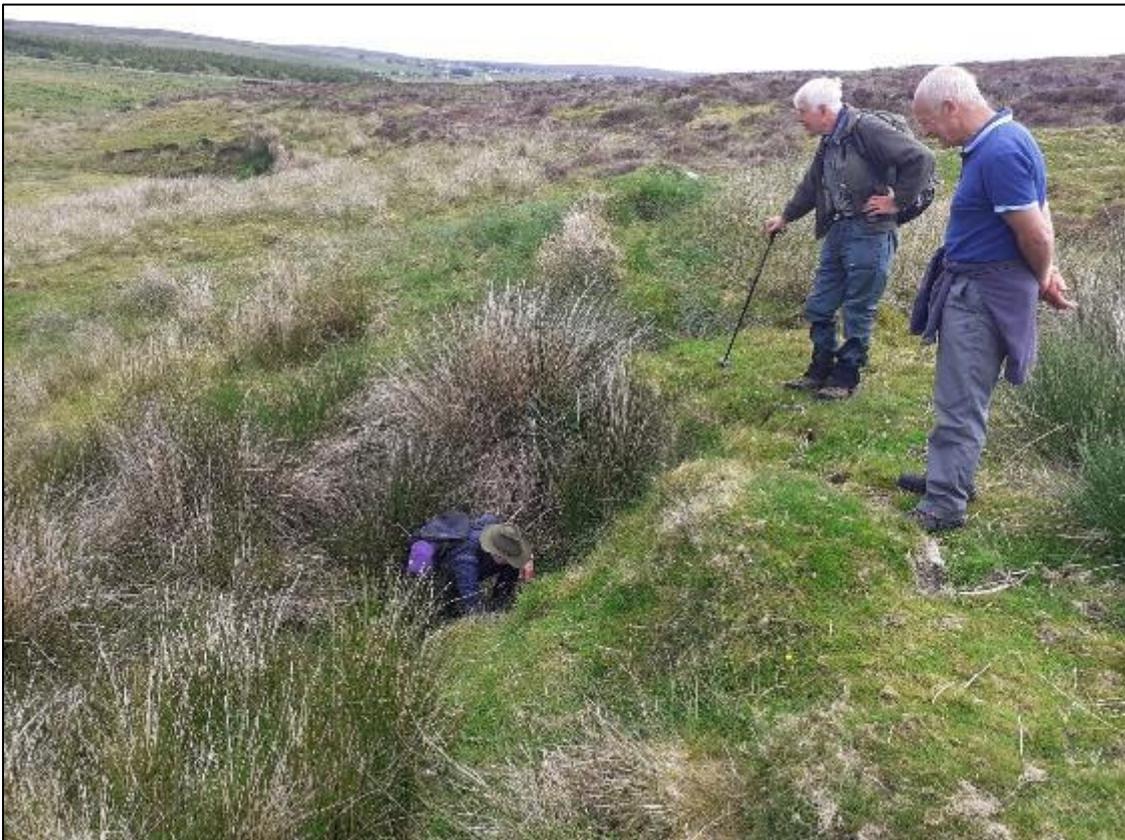
Strangely, a square section of the bank c2m x 2m, where it ran between the enclosure and the floodplain, seemed to be missing – see figure 17. If roofed, it would have been very well hidden. This was again reminiscent of the illicit still sites.

Figure 17: Site 6 was missing a square section of bank... might this have been another illicit still??

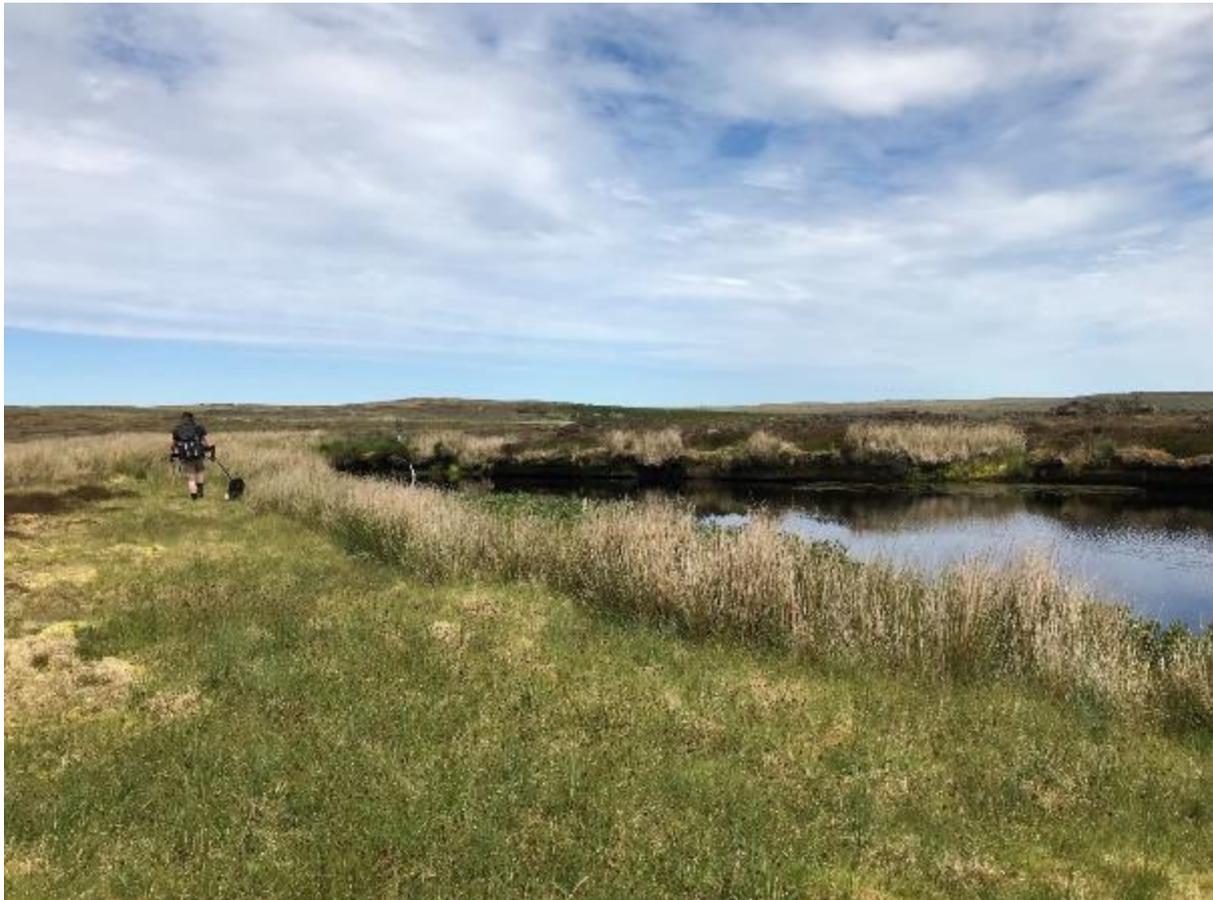
Next we arrived at the Loch an Eallaich, **Site 8**. DI had been told that there were stills here too, and that 5 people were charged with illegal distilling at this site in 1820. We didn't find the sites for stills, although there were a series of sections of peat bank missing – the reedy sections on the far bank in Figure 20 below. These were on the far side of the loch, requiring the crossing of ditches or streams and as our route took us the other way, we didn't explore them in detail – although perhaps we should have! Instead we headed for the “Ruin” marked nearby on the 1st edition (Canmore ID 136435, Site Number NB44SE 34, NGR NB 4625 4084), which we looked for and likewise did not find. The heather and moss is so deep here that walking is very tough and finding archaeology under it even tougher. As “Ealaich was thought to mean something like “burden”, we wondered if this was why. Presumably if it was always like this then that is why it would have been a good place for an illicit still!

Figure 20: The west bank of the Loch an Eallaich.

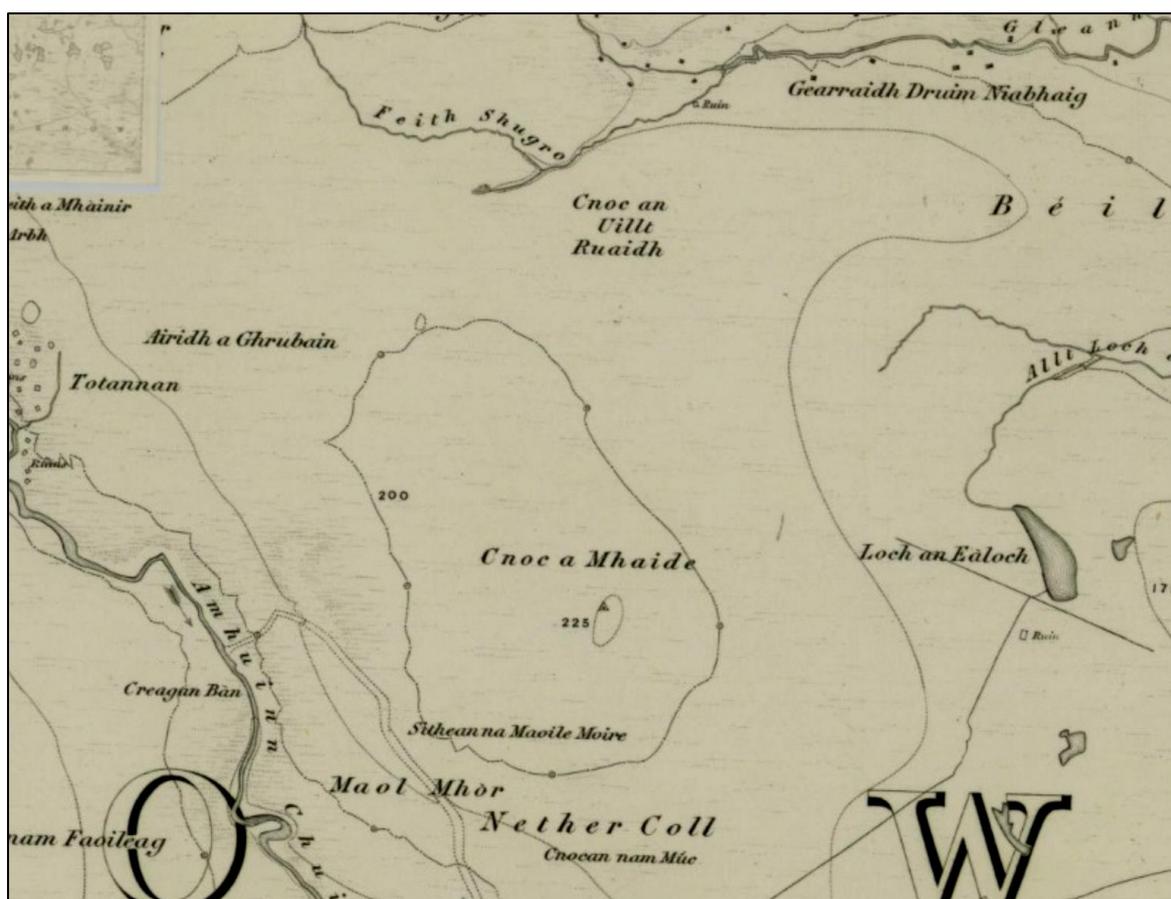
Fig 23 – Site 9. Cnoc a Mhaide / something like Hillock of the Sticks according to Margaret Martin (CEBAC publication).

We could not find any trace of a field system, and only one main mound at the Cnoc summit. This Cnoc has outstanding views of the area, and is quite some distance from any water source. This location lead us to wonder whether it could have actually been the remains of a chambered cairn, like Carn a Mharc, rather than a settlement mound.
